## Geotechnical characteristics of soils from Tourela artisanal gold mining site in Mali and restoration proposals

World Journal of Advanced Research and Reviews, 2025, 28(03), 2300-2314

The village of Tourela is facing progressive degradation of its soils due to unregulated mining activities. The main objective of this research is to study the evolution of the geotechnical characteristics of soils as a function of excavation depth, through field investigations followed by drilling and laboratory tests, in order to understand their mechanical and physical behavior in a post-exploitation context. Grain size analysis, bulk density, and moisture content tests were carried out to determine the physical parameters. The Atterberg limits test was conducted to determine the soil consistency parameters. The mechanical parameters, such as cohesion and the angle of internal friction, were determined through direct shear testing. In the perspective of backfilling mining excavations, the Proctor test was performed to evaluate the maximum compaction energy of the fill material, both on the soil without additives and with the incorporation of 25% and 50% of crushed gravel in the backfill mass.

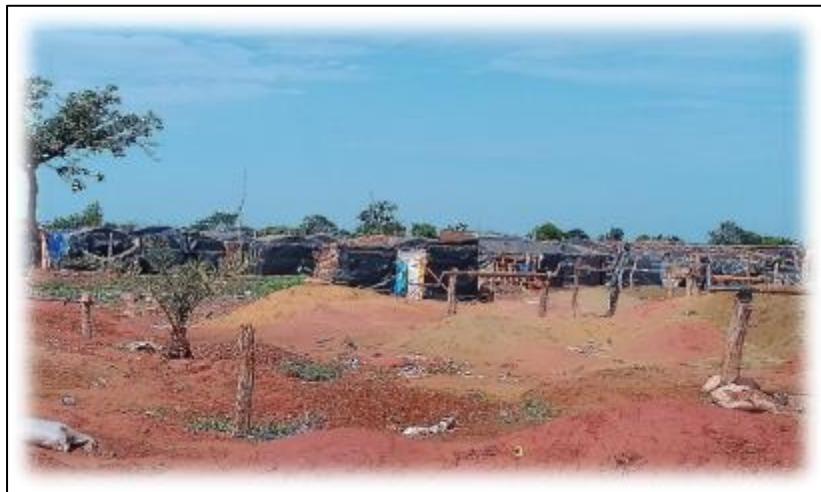
**Figure 1** Tourela gold panning site

Tourela gold mining site is one of many sites where local people extract gold using traditional techniques (Figure 1).

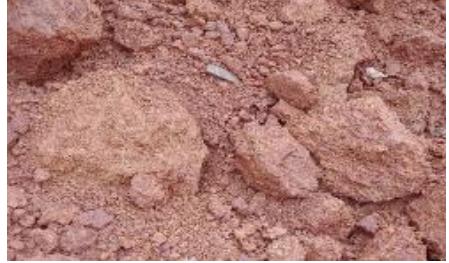
Depth (m)		Visual observations	Photos
From	To		
0	5	Reddish-colored soil containing solid gravelly grains

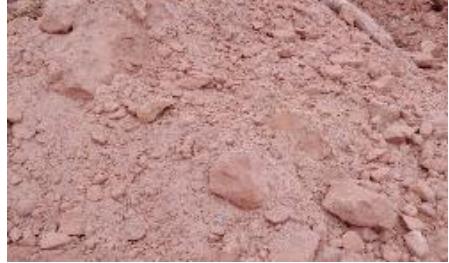
5	20	Light red powdered soil

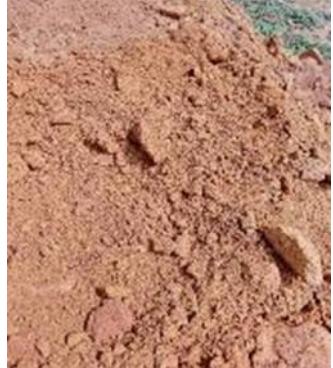
20	30	The soil is yellow with a sandy texture.

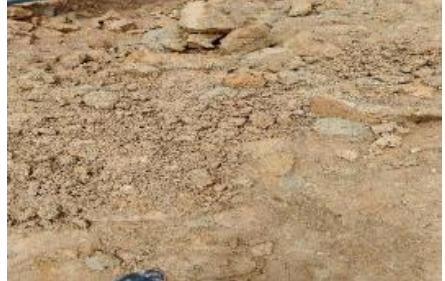
30	35	Composed of yellow and grey colored elements, the solid elements can easily be reduced to fine particles under the action of a one-handed press.

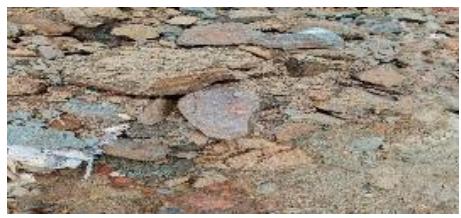
35	40	Composed of layers of grey soil and hard rocks, difficult to reduce into fine particles.

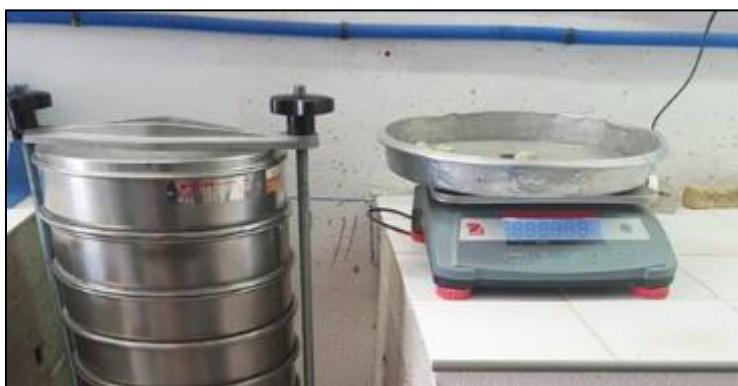
The purpose of this test is to determine the particle size distribution of aggregates with dimensions ranging from 0.08 to 80 mm (Figure 2). It consists of separating a material into several granular classes of decreasing sizes using a series of sieves.[8]

The objective is to obtain the particle size distribution curve, which allows for the interpretation of soil texture and its suitability for construction and landscaping work. The equipment used includes: an oven, a series of sieves, and a balance.

**Figure 2** Materials for particle size analysis

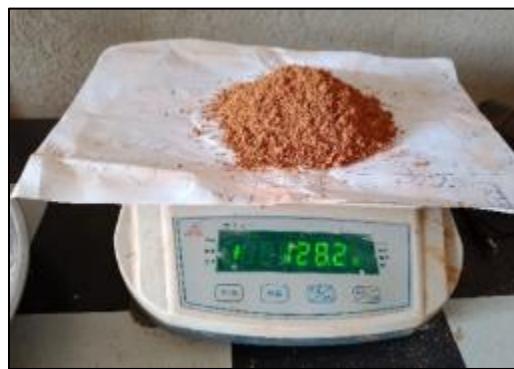
The water content of a material is the ratio of the weight of water contained in that material to the weight of the same material when dry[9]. Water content is a state parameter that allows us to approximate certain mechanical characteristics and assess the consistency of a fine soil. The equipment used includes: an oven, a tare weight, and a balance (Figure 3).

**Figure 3** Precision balance

The determination of water content is carried out by weighing the sample in its initial (wet) state and after passing through the oven at  $105^\circ\text{C}$  until constant mass is reached [10].

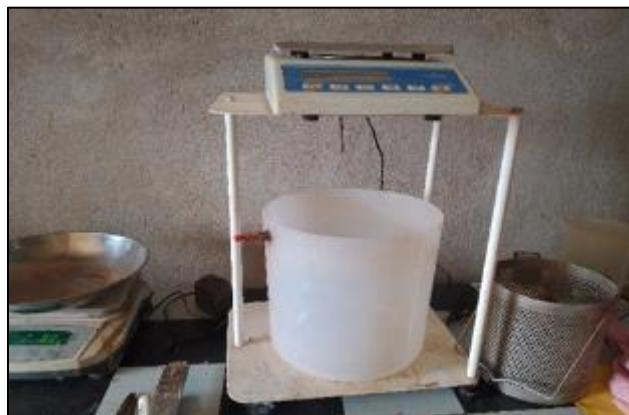
Apparent density is an indicator of soil compaction (Figure 5). It is calculated as the dry weight of the soil divided by its volume, where,  $m$  and  $V$  are the mass and volume of the sample (g) [11]. The materials used are: Paraffin wax, a beaker, and a balance.

**Figure 5** Hydrostatic weighing**Table 1** Apparent soil density

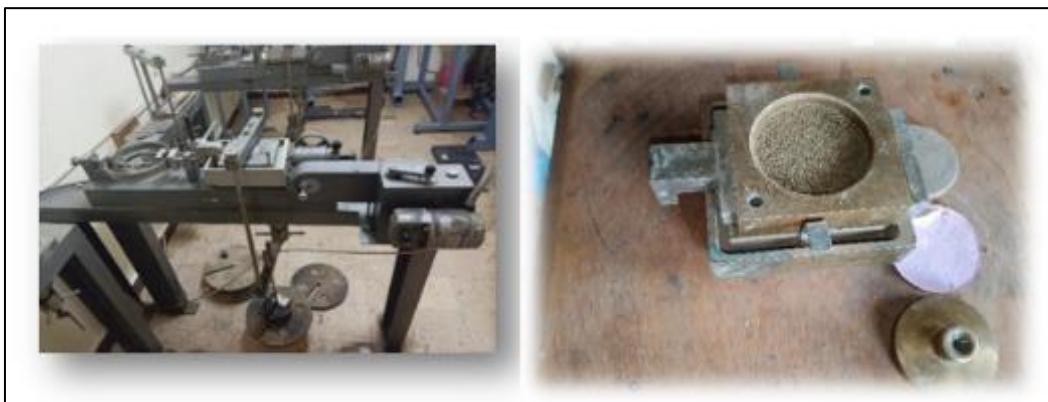
The aim is to experimentally determine the intrinsic curve of a soil, and then to deduce the shear parameters (the angle of internal friction and the cohesion, where a normal stress  $\sigma$  is imposed and then the soil is sheared)[14]

The objective is therefore to determine the angle of internal friction ( $\phi$ ) and the cohesion ( $c$ ) of the material (Figure 8).

**Figure 8** Shear box

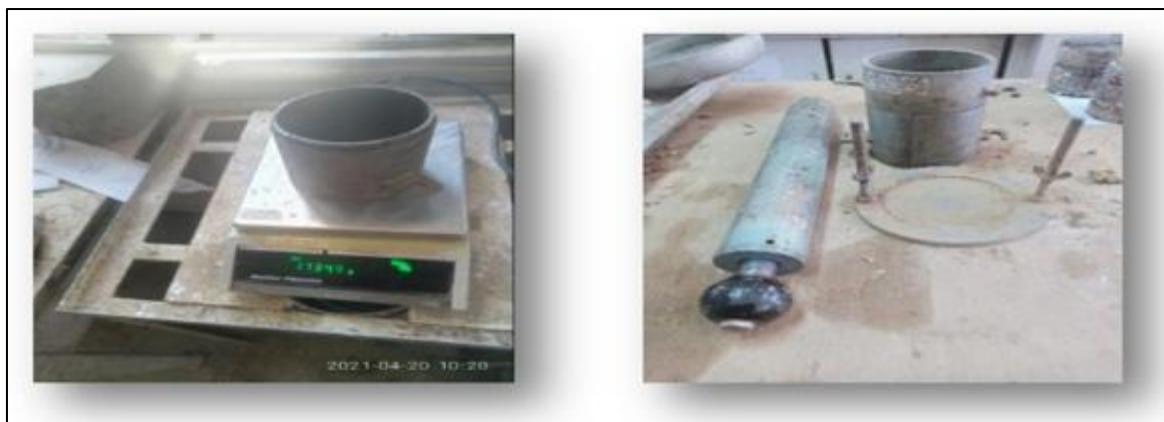
The Proctor test (Figure 11) is a geotechnical test used to determine the water content required to achieve the maximum dry density of a granular (or non-granular) soil through compaction. Compaction remains the most economical method still used in embankment construction to improve soil dry density[15].

**Figure 11** Proctor test equipment [14]

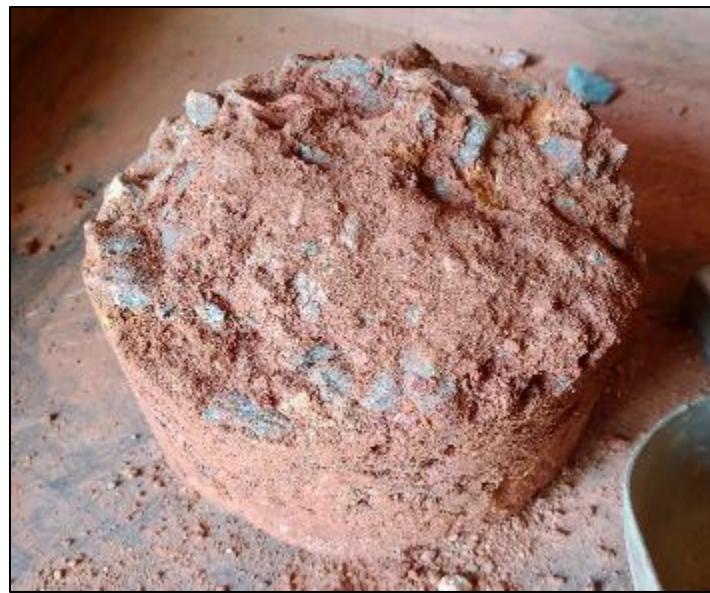
Compaction carried out on the ground without additives and with the addition of crushed gravel at 25% and 50% indicates (Table 13) that the performance of the embankment during compaction improves with the addition of gravel, with an increase in dry density and a decrease in the optimum water content, which can be related to the cohesion with granular materials (Figure 15) and the fewer water content from the added materials.

**Figure 15** Sample after compaction containing crushed gravel
